**The State of West Virginia  
Community Development Block Grant  
Mitigation (CDBG-MIT) Training**

# Innovative MIT Project Examples

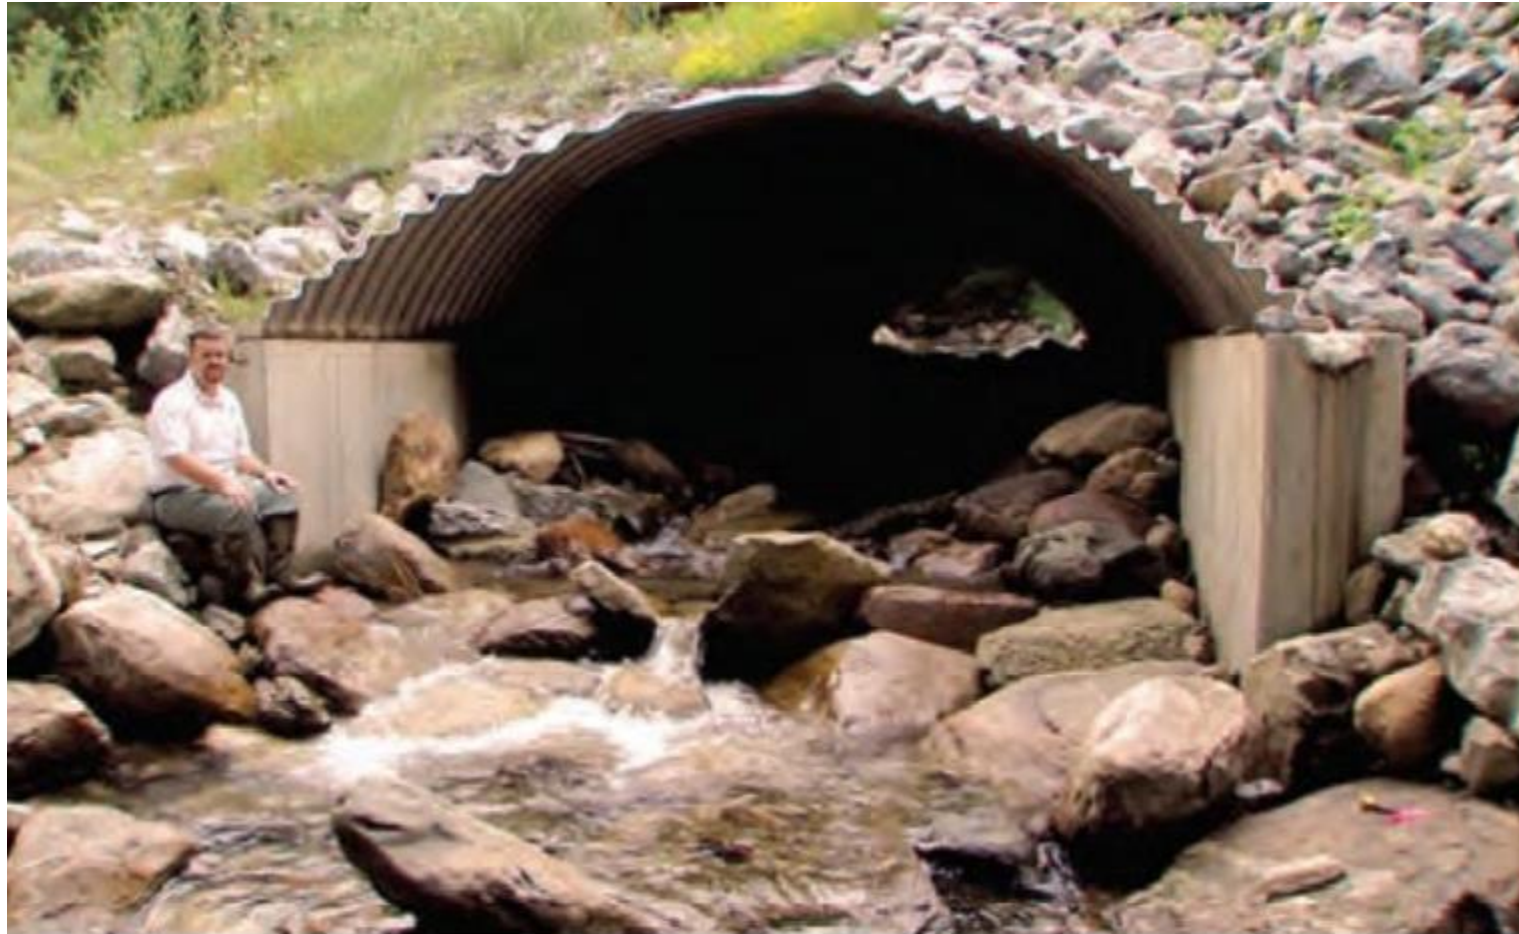
# Natural Fish Passages – Arlington, VT and Salsipuedes, CA

- ❑ Reconstructed culverts or channels use rocks, sand and/or boulders to simulate stream conditions
- ❑ Natural materials are more durable and structurally sound, reducing maintenance
- ❑ Beneficial impact on endangered species by promoting safe fish passage
- ❑ Can use native plants to create aesthetically appealing and eco-friendly surroundings
- ❑ [Design for Fish Passage at Roadway-Stream Crossings: Synthesis Report \(dot.gov\)](#)
- ❑ [Designing Passage for Humans Above and Fish Below | Client Story | ICF](#)

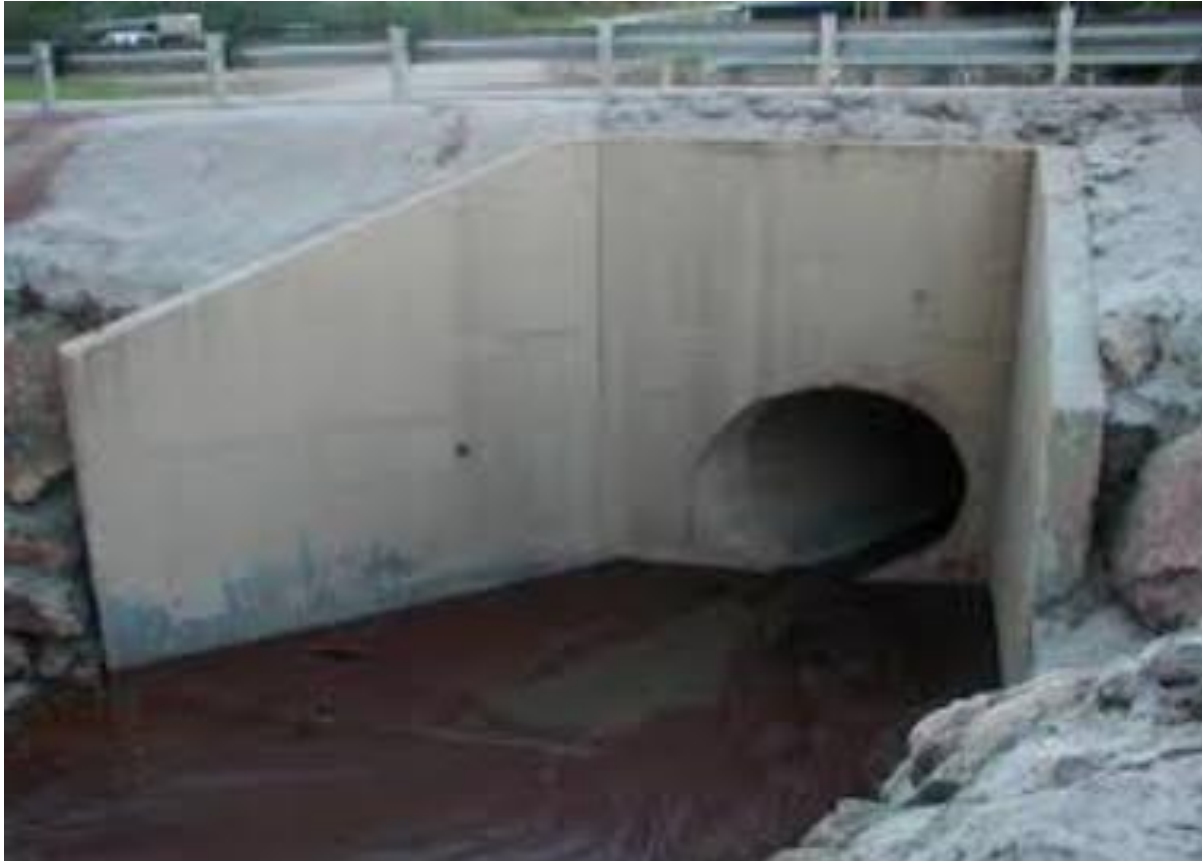
# Standard Culvert Design

- Concrete or corrugated metal subject to failure
- Does not promote safe fish passage
- Constricts stream flow, increasing risk of obstruction and further flooding
- Lack of aesthetic appeal

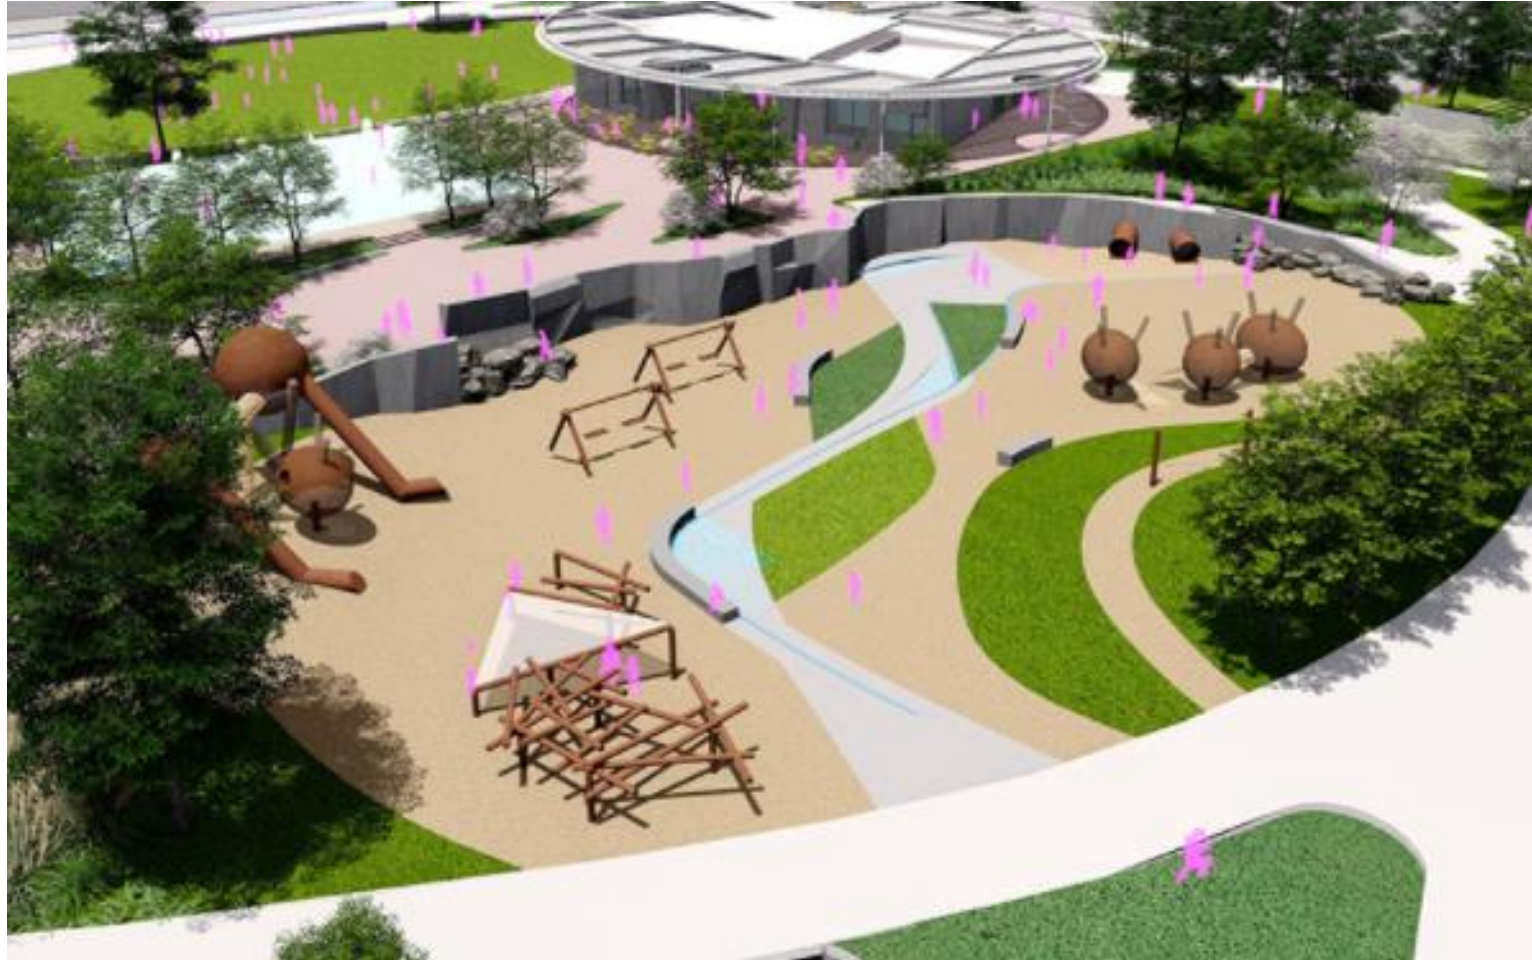
# Northwest Resiliency Park – Hoboken, NJ

- ❑ Former industrial site to become a park that will provide amenities to residents while reducing localized flooding
- ❑ Designed with integrated green infrastructure to manage approximately 1 million gallons of stormwater runoff
- ❑ The project will filter and store stormwater, recycle runoff for use as irrigation and toilet flushing, and reduce combined sewer overflows to the Hudson River
- ❑ Amenities will include discovery gardens, play valley, athletic field, basketball basin, water feature/ice rink and more
- ❑ [Northwest Resiliency Park \(arcgis.com\)](http://arcgis.com)

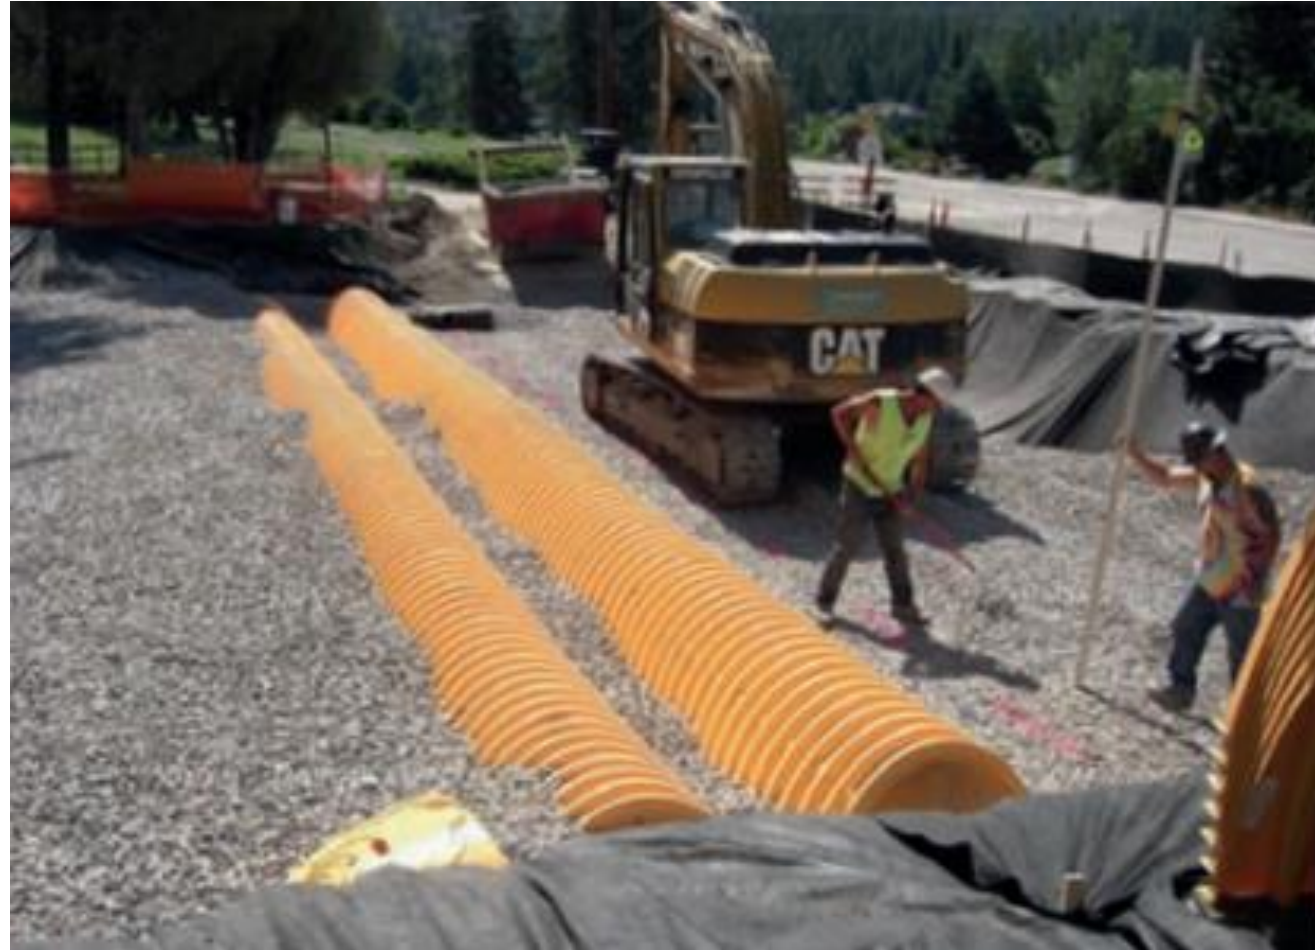
# Stormwater Project – Big Fork, MT

- ❑ Roofs and parking lots of Big Fork schools were contributing to flooding on Grand Drive
- ❑ Underground Stormtech detention and filtration system were installed on the Elementary playground to capture runoff
- ❑ Five new drywells were installed in the school parking areas
- ❑ These two systems combined have reduced reduced stormwater entering the conveyance system to Bigfork Bay by as much as 85%
- ❑ [Popout Hanson.pdf \(flatheadwatershed.org\)](#)

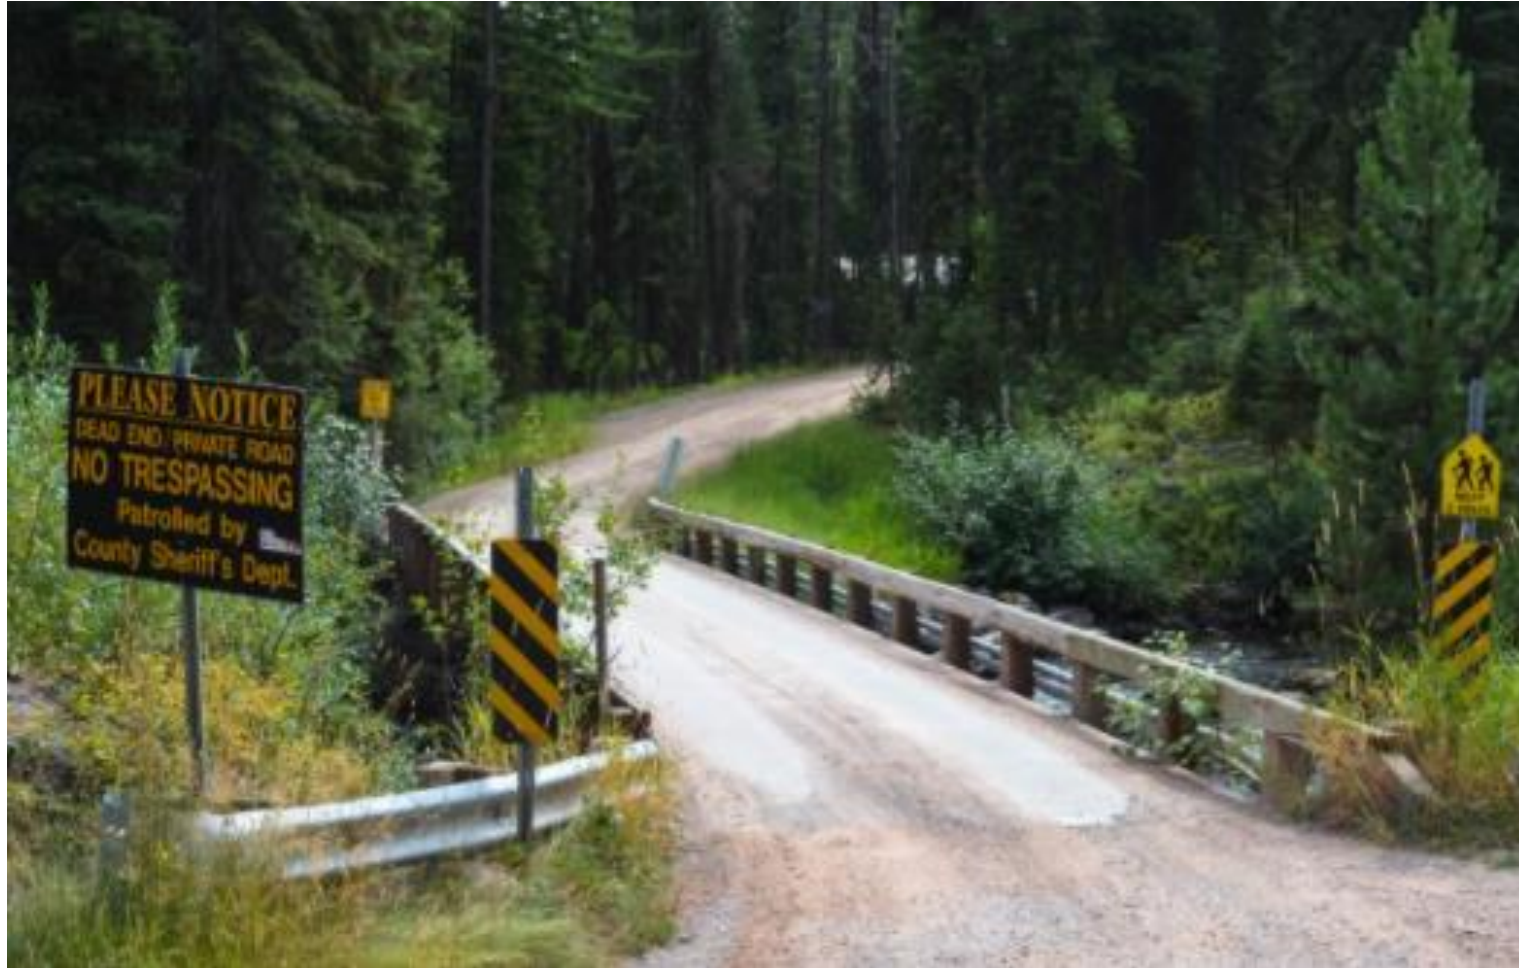
# Home Access Program – Colorado Springs, CO

- ❑ Repairs or reconstructs private roads, bridges and culverts for homeowners and renters
- ❑ Ensures occupants can access their homes and evacuation routes
- ❑ Grants and forgivable loans funded with CDBG-DR
- ❑ Qualified under LMH (Low-Mod Housing) National Objective
- ❑ <https://cdola.colorado.gov/disaster-recovery-home-access>

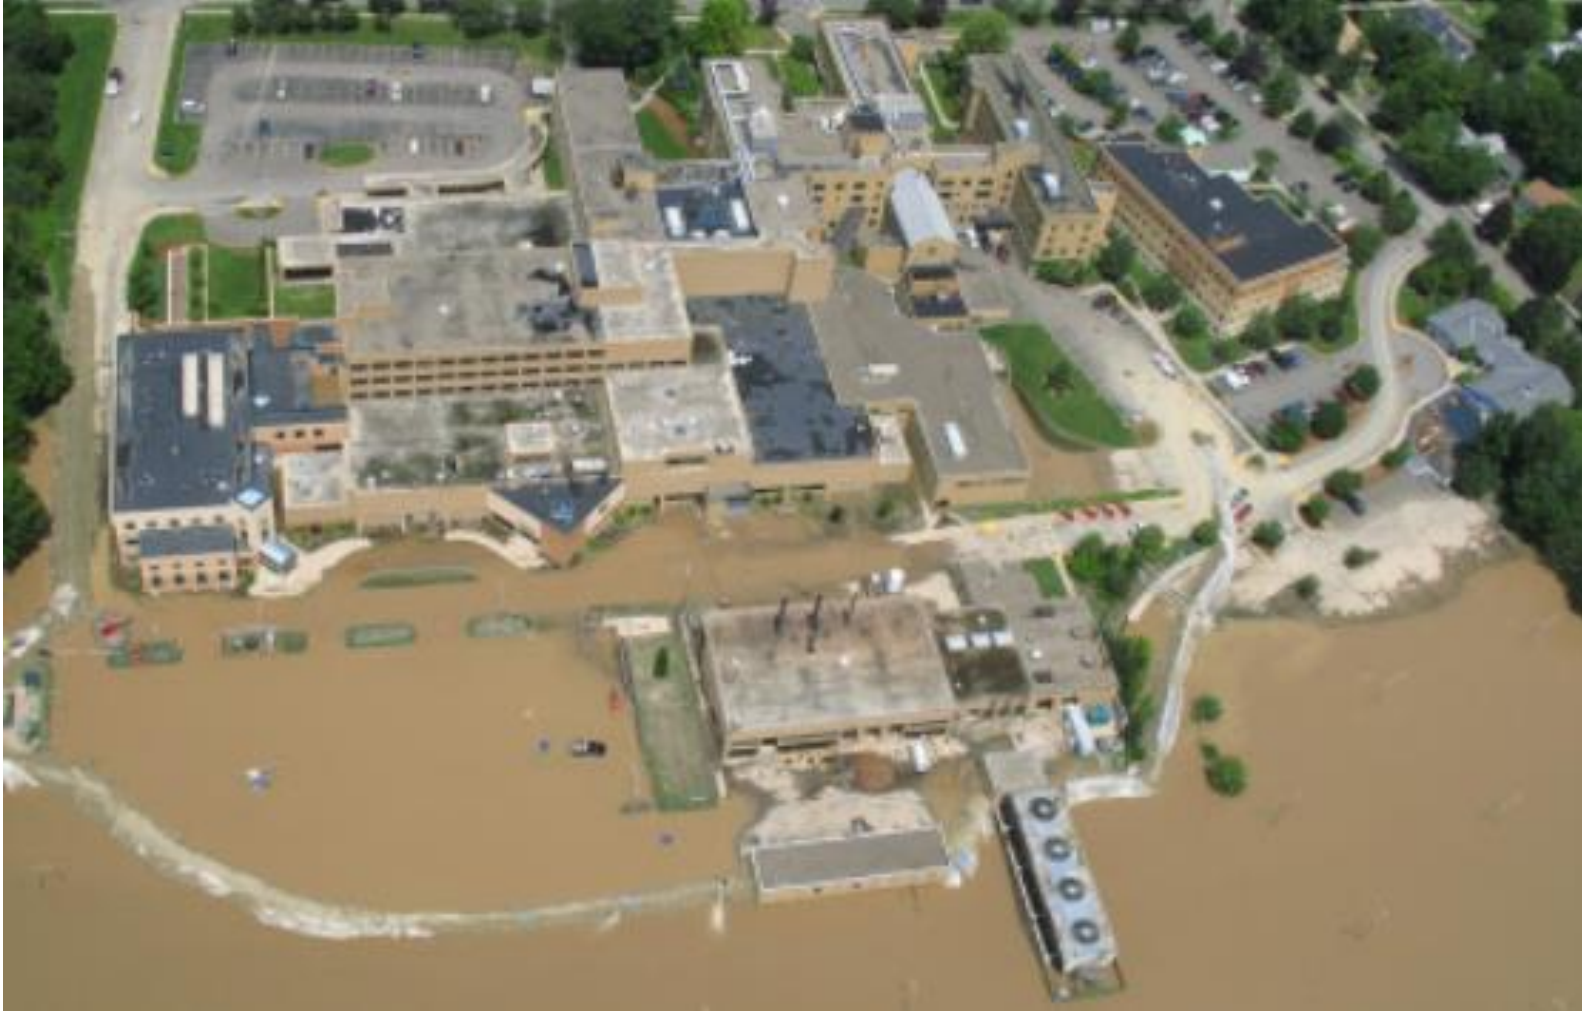
# Hospital Flood Mitigation – Binghamton, NY

- ❑ In 2006 the Susquehanna River overflowed its banks, causing flood waters to inundate Our Lady of Lourdes Hospital in Binghamton. The entire first floor at ground level was submerged under 16 to 20 inches of flood water contaminated with raw sewage. The hospital was shut down and all patients were evacuated for several days.
- ❑ Proposed mitigation measures included a solid concrete flood wall that would be located at the west, south, and east sides of the facility, and would be equipped with automatically activated flood gates and pumping system that would engage, should floodwaters enter the facility.
- ❑ [FEMA Funding For Binghamton Hospital After Flood Damage » Tidal Basin \(tidalbasingroup.com\)](#)

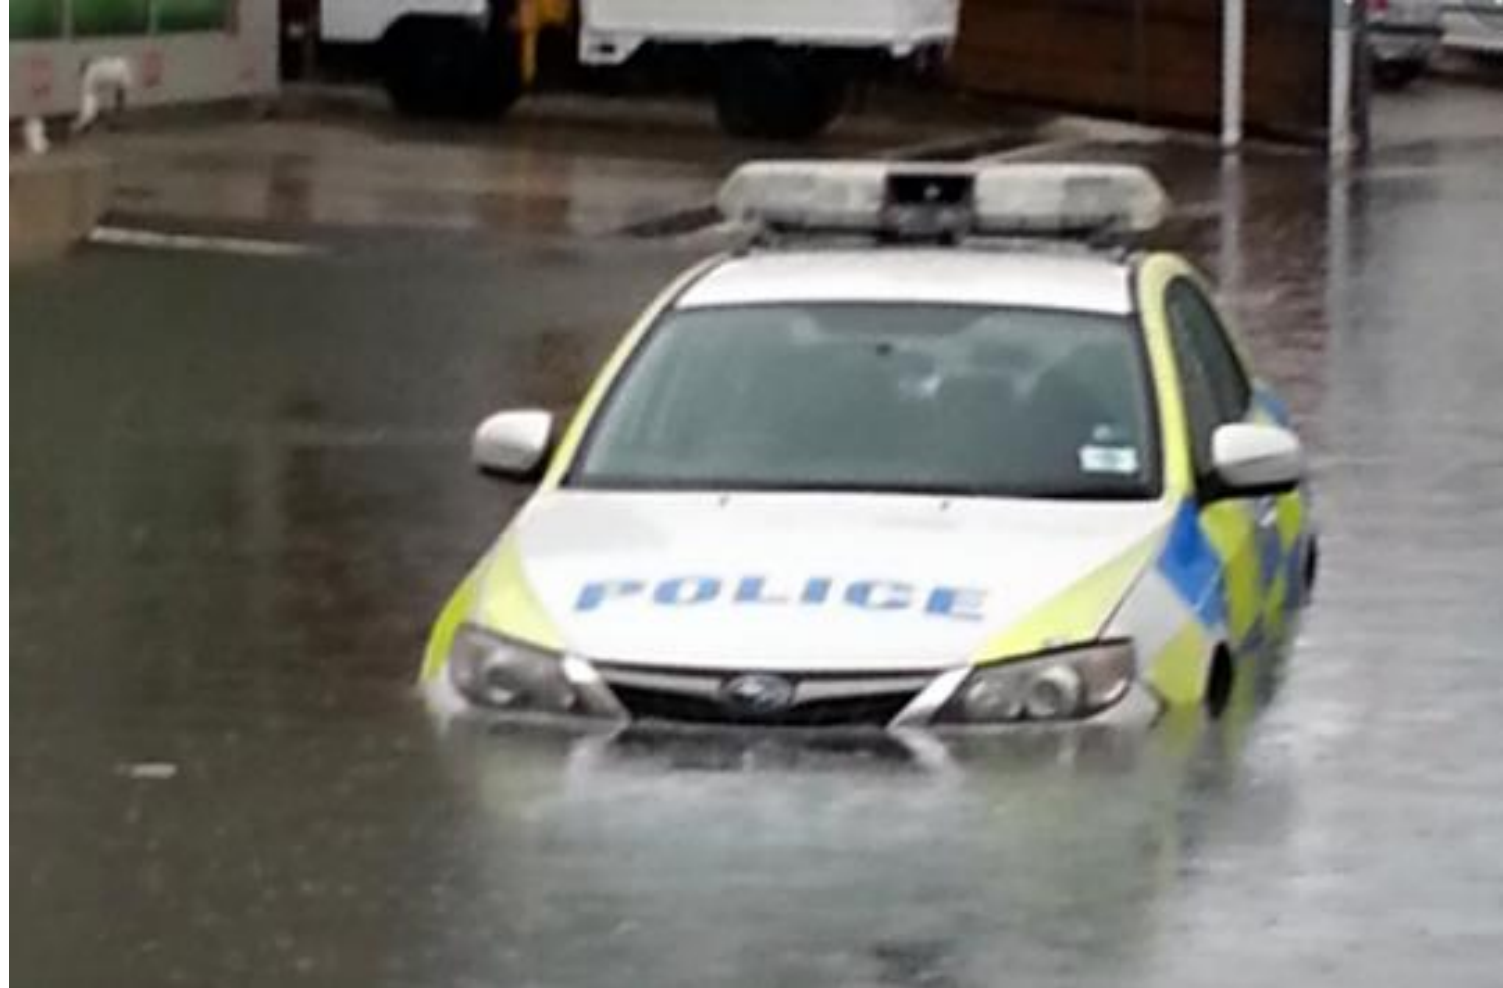
# Police and Fire Station Flood Mitigation – Peabody, MS

- During the “Mother’s Day Flood” of 2006, water levels rose in the basements of both the police and fire stations in Peabody, MA.
- All critical systems were housed in the basements – Emergency Management Director stated, “We were within 3 inches of losing our 911 system.”
- Mitigation measures included upgrading and redirecting 911 system, purchasing a new generator and pumps, construct an elevated exterior room and relocate all equipment to the new room.
- [Several Small Steps Lead to Safety | FEMA.gov](#)

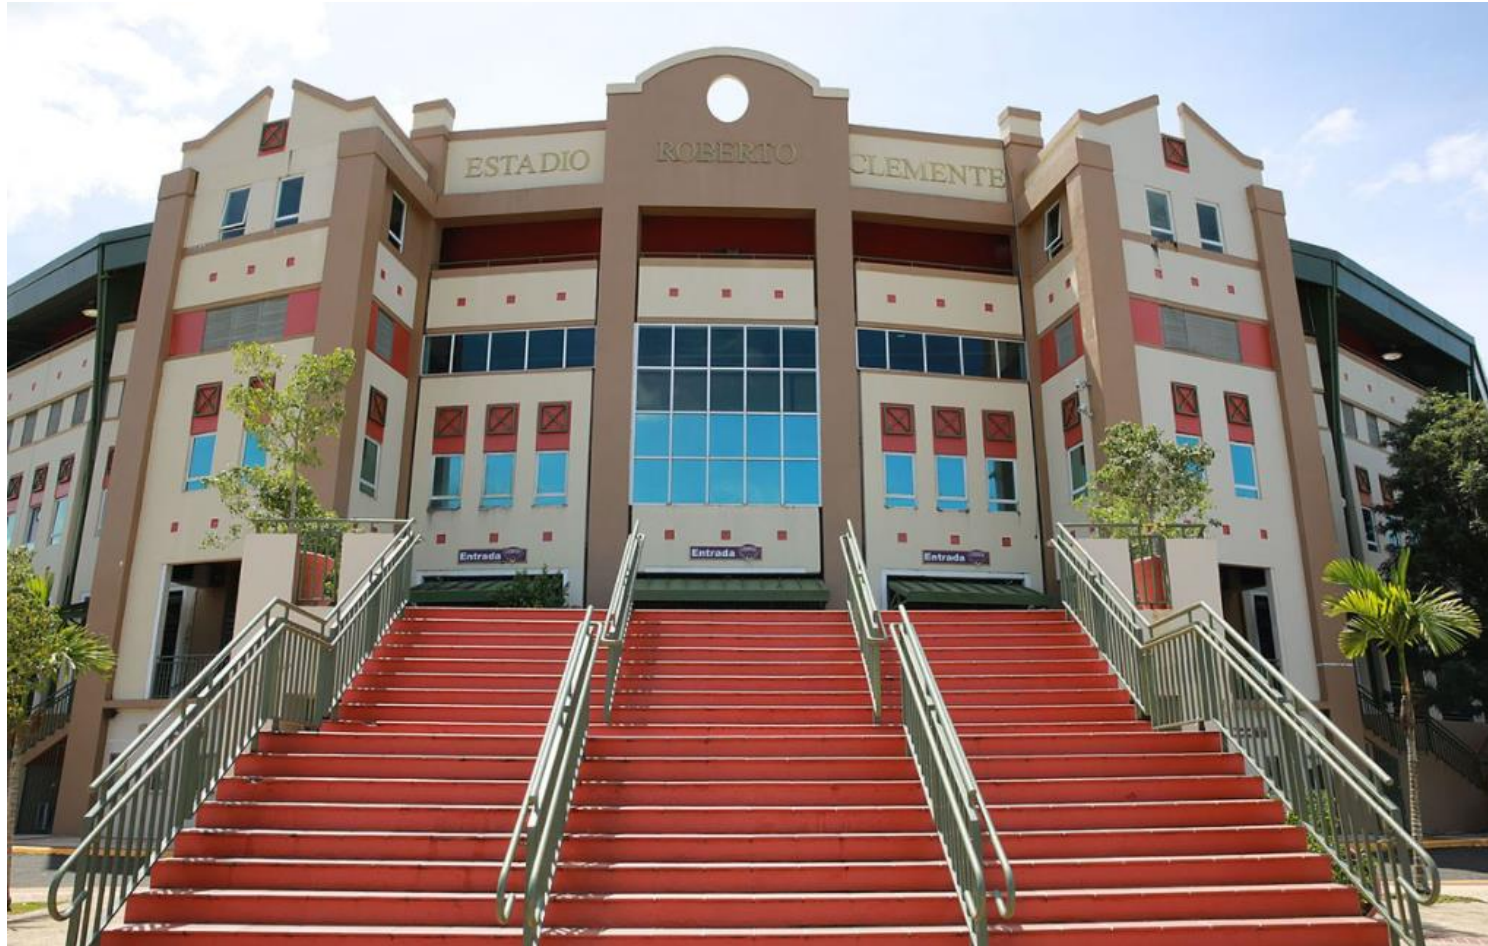
# Roberto Clemente Stadium – Carolina, PR

- ❑ Sports facility that also serves as a meeting center was impacted by Hurricanes Irma and Maria
- ❑ Mitigation measures included adding a surge protector to protect electrical equipment, replacing acoustical drop ceiling tiles with a water and mold resistant ones, replacing fiberglass poles with aluminum poles and substituting gypsum board with water resistant dry wall
- ❑ [FEMA Obligates \\$9.5 Million to Repair the Roberto Clemente Municipal Sports Complex | FEMA.gov](#)
